INSPECTION REPORT

For the Property at:
321 HIGH RD.
HAMMOND., ON K0A 2A0

Prepared for: JOHN DOE
Inspection Date: Saturday, August 10, 2019
Prepared by: Daniel Ducheneaux

RE: Report No. 1005, v.5
321 High Rd.
Hammond., ON
K0A 2A0

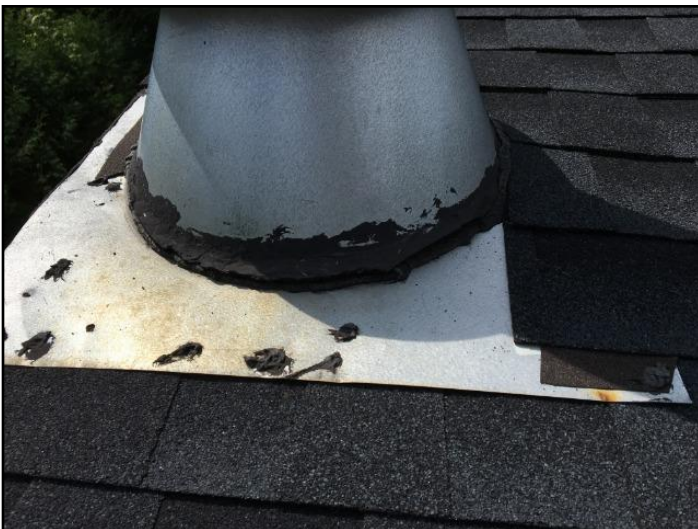
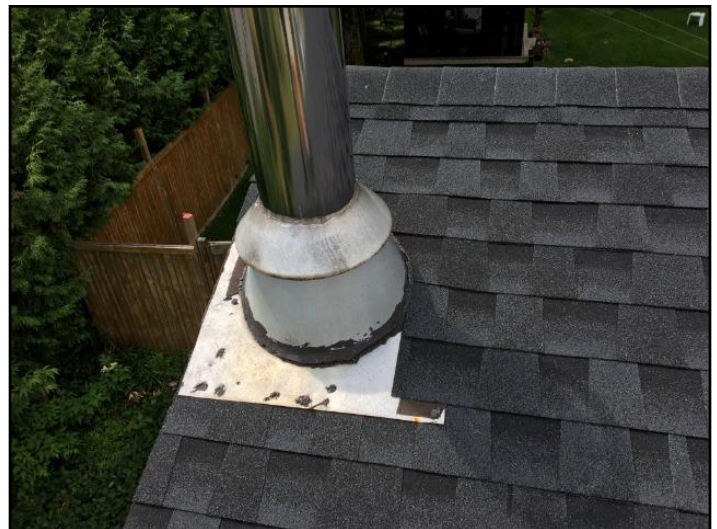
Condition: • [Damage, loose, open seams, patched](#)

Chimney flashing for hot water heater shows signs of previous repairs. No evidence of leakage was noticed at time of inspection

Implication(s): Chance of water damage to contents, finishes and/or structure

1. Damage, loose, open seams, patched

Task: Monitor

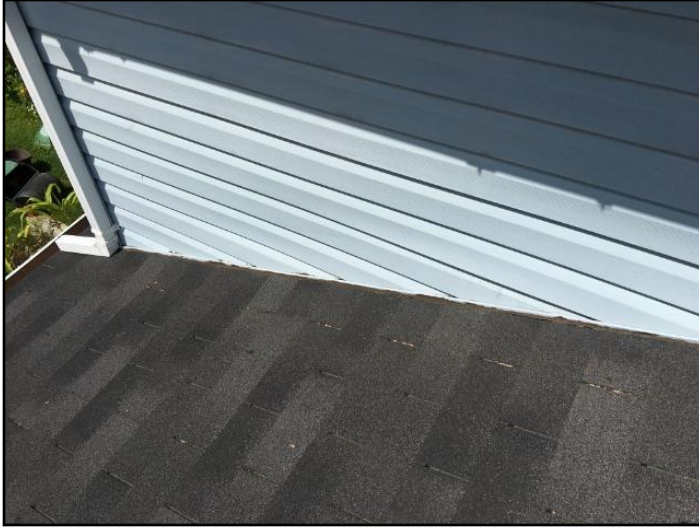
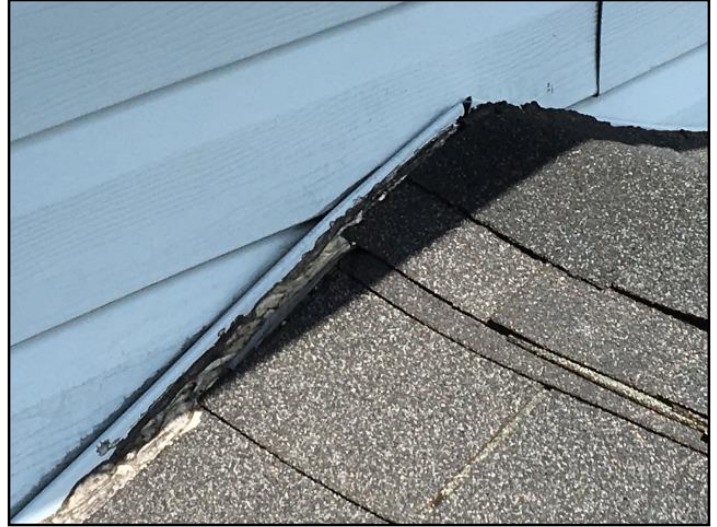
Condition: • [Damage, loose, open seams, patched](#)

Upper floor wall that intersects with lower roof shows signs of previous repairs. No evidence of leakage was noticed at time of inspection

Implication(s): Chance of water damage to contents, finishes and/or structure

3. Damage, loose, open seams, patched

Task: Monitor

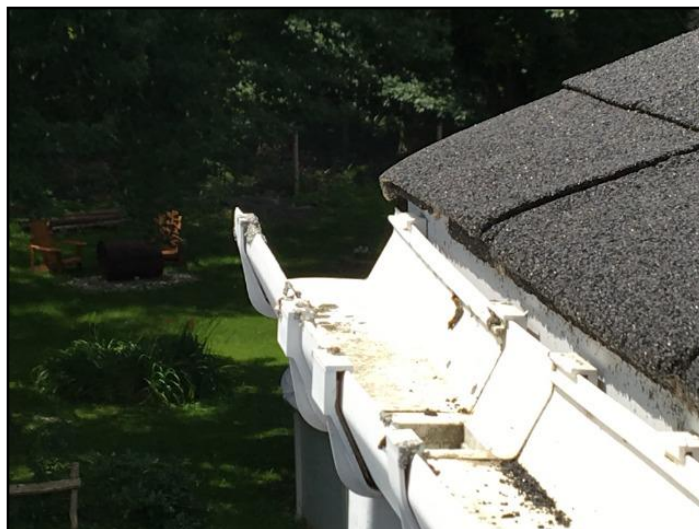
5.

Condition: • Gutter end cap is missing on upper roof gutter.

Implication(s): Water damage to structure and grading

Task: Provide

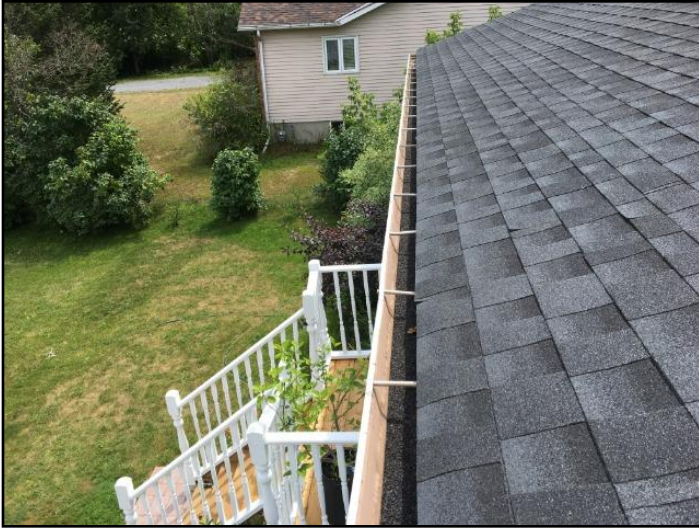
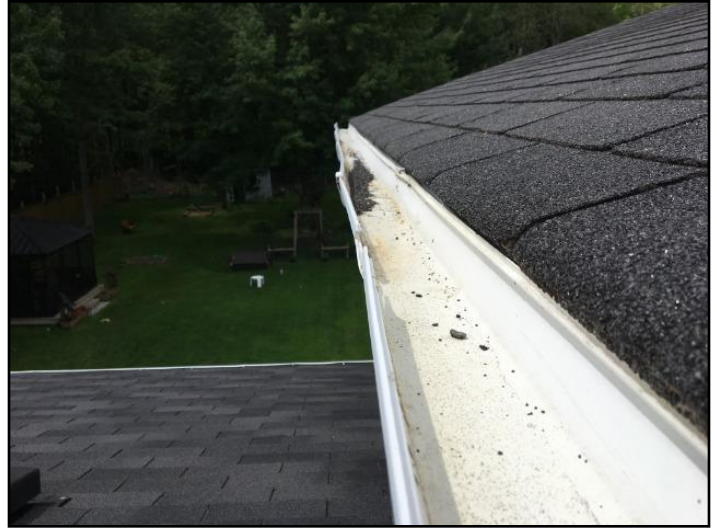
Condition: • Dirty/debris

6. Dirty/debris

Task: Clean

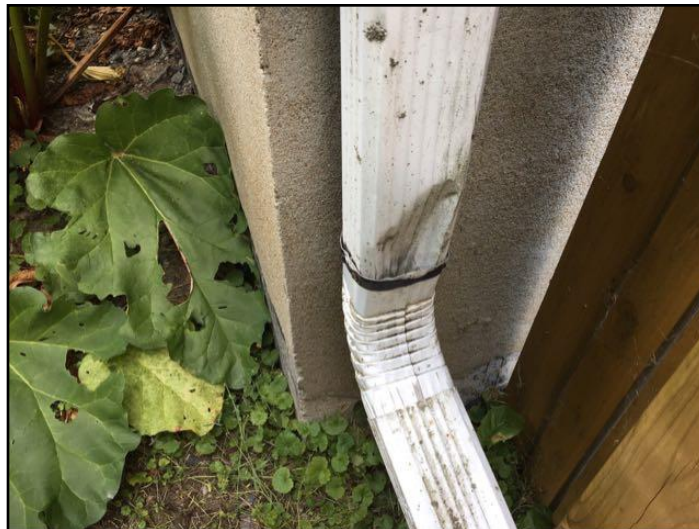
Condition: • [Damage](#)

Implication(s): Chance of water damage to contents, finishes and/or structure

8. Damage

Task: Repair or replace

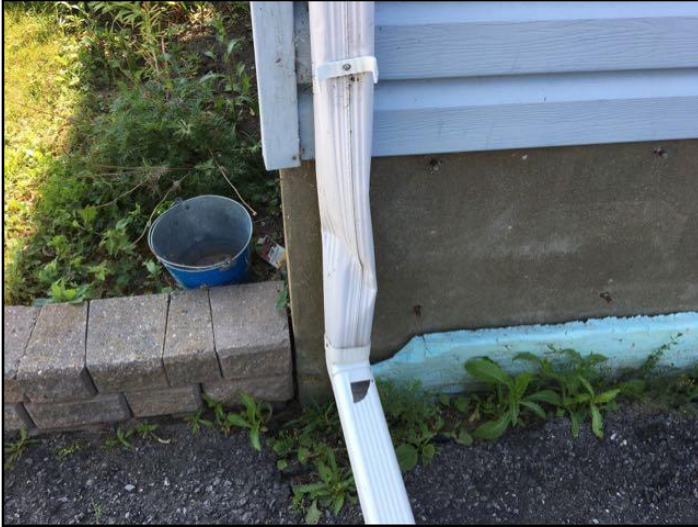
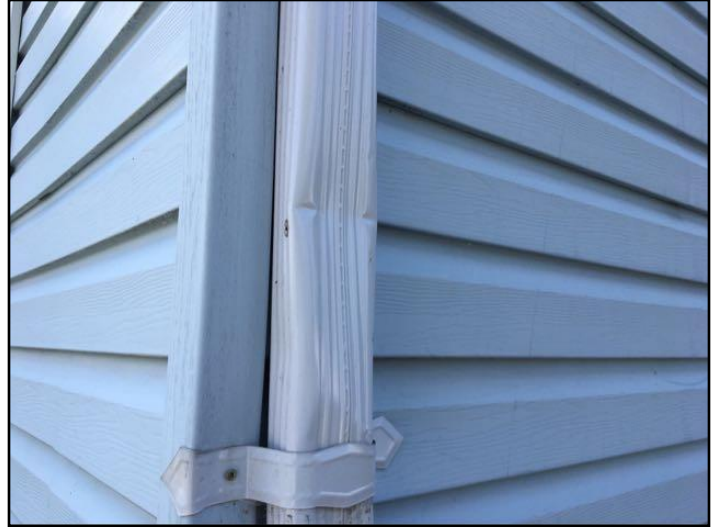
Condition: • [Damage](#)

Implication(s): Chance of water damage to contents, finishes and/or structure

9. Damage

Task: Repair or replace

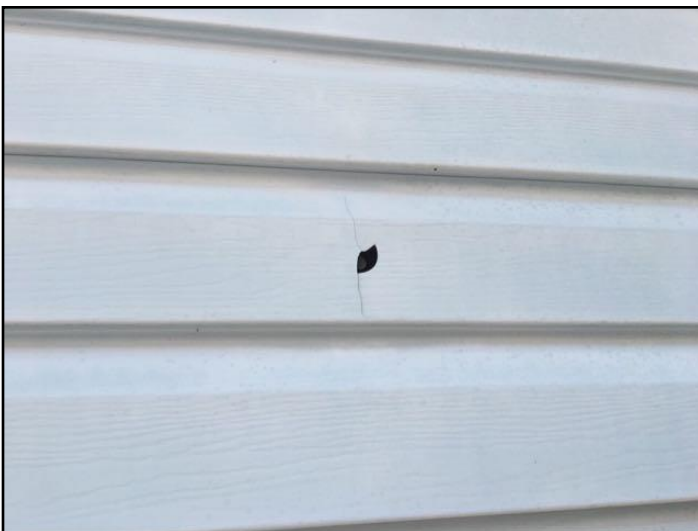
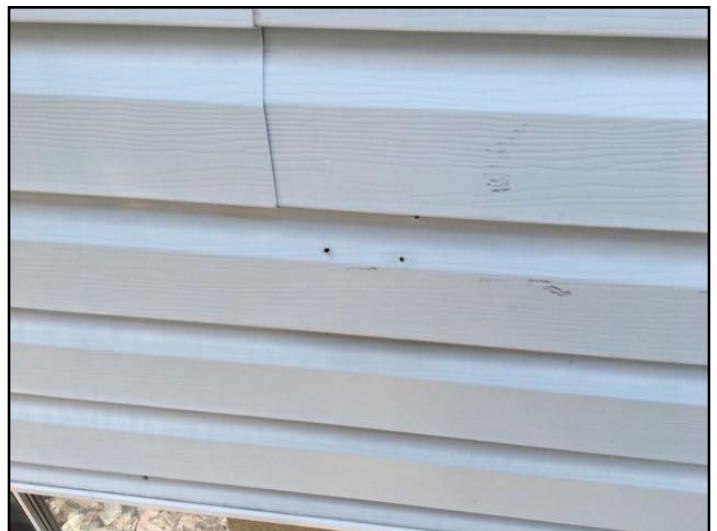
Condition: • [Mechanical damage](#)

This is a minor repair but should be performed as early as possible.

Implication(s): Chance of water damage to contents, finishes and/or structure

11. Mechanical damage

Caulking is recommended.

Task: Repair

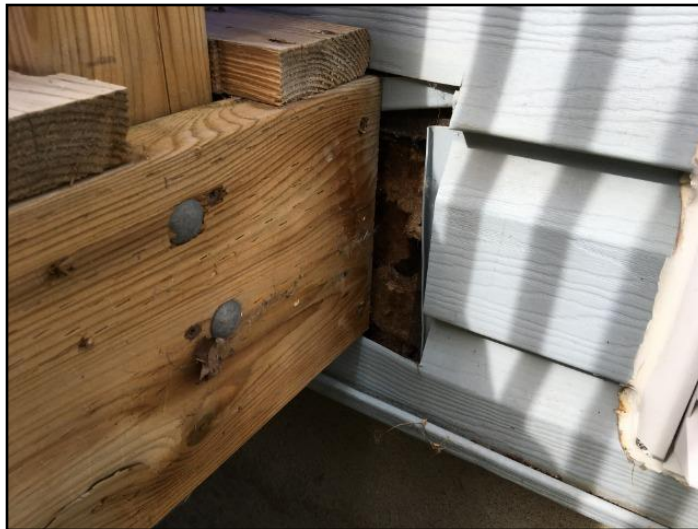
Condition: • [Loose or missing pieces](#)

Open gap at the rear entrance porch.

Implication(s): Chance of water damage to contents, finishes and/or structure

13. Loose or missing pieces

Task: Repair

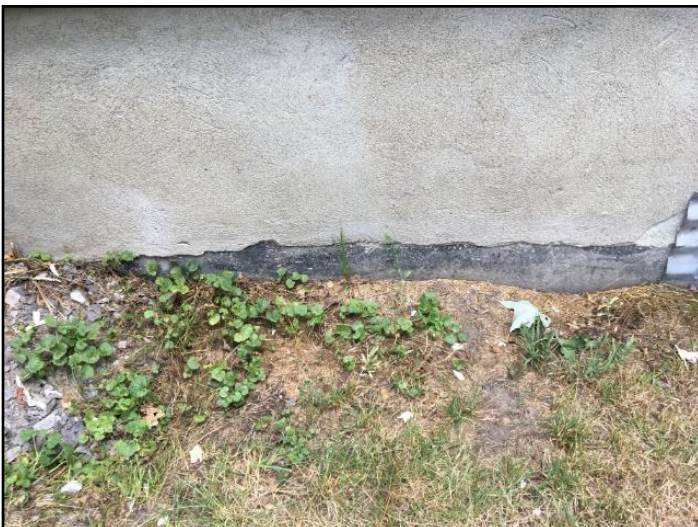
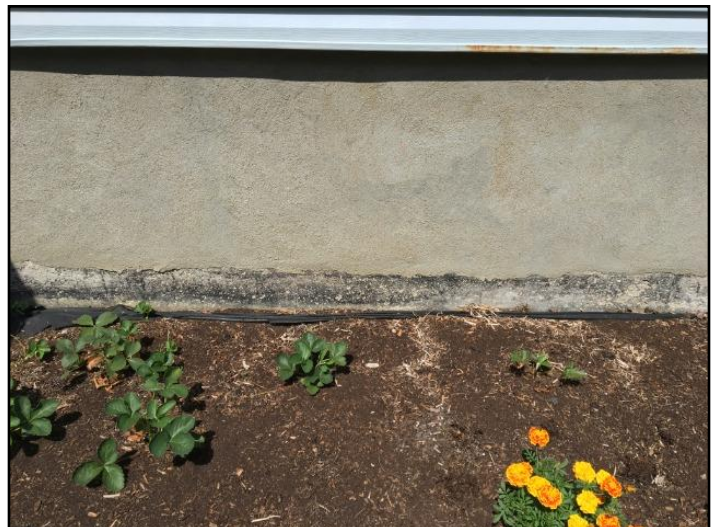
Condition: • [Parging damaged or missing](#)

Parging will need maintenance on all sides of the house

Implication(s): Chance of damage to structure | Shortened life expectancy of material

14. Parging damaged or missing

Task: Repair

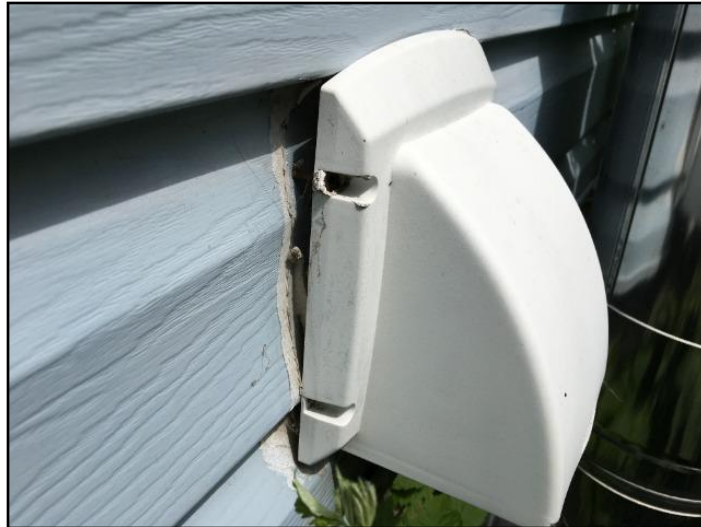
16.

Condition: • Open gap

Implication(s): Water infiltration

Task: Improve

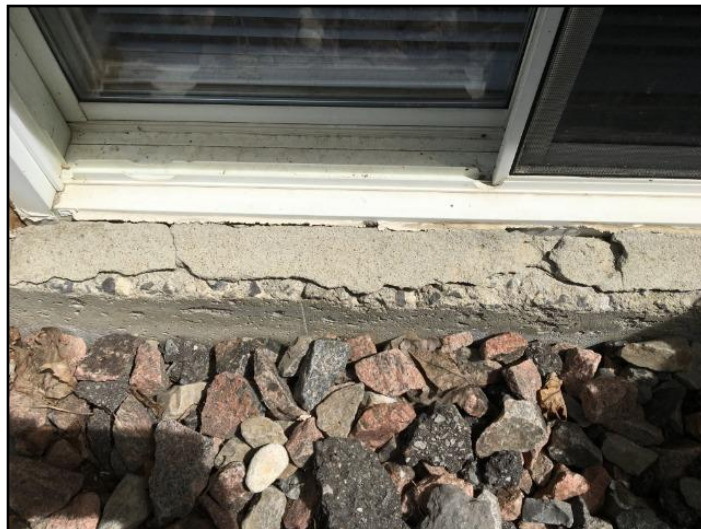
Condition: • [Sill deteriorated](#)

Implication(s): Material deterioration

17. *Sill deteriorated*

Task: Repair

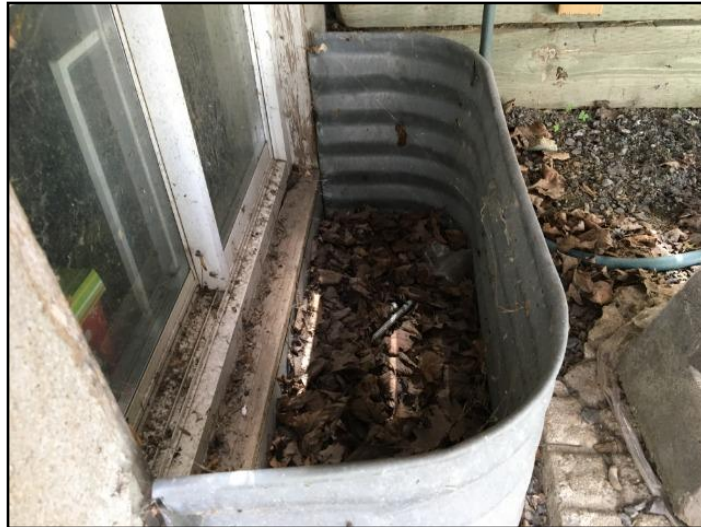
18.

Condition: • Debris/leaves

Implication(s): Possible water infiltration

Task: Monitor/clean

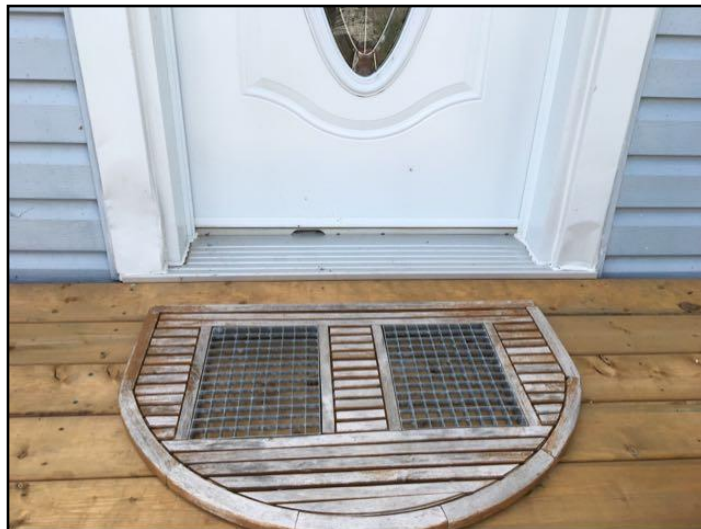
Condition: • [Sill too low](#)

Implication(s): Chance of damage to finishes and structure

19. *Sill too low*

Task: Improve

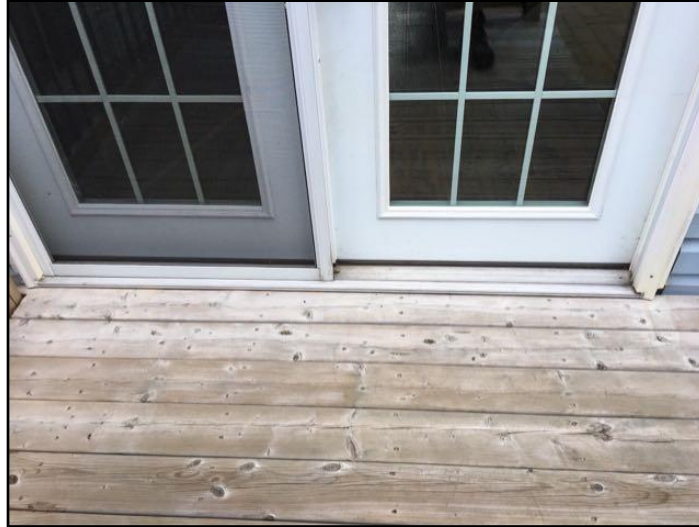
Condition: • [Sill too low](#)

Implication(s): Chance of damage to finishes and structure

20. *Sill too low*

Task: Improve

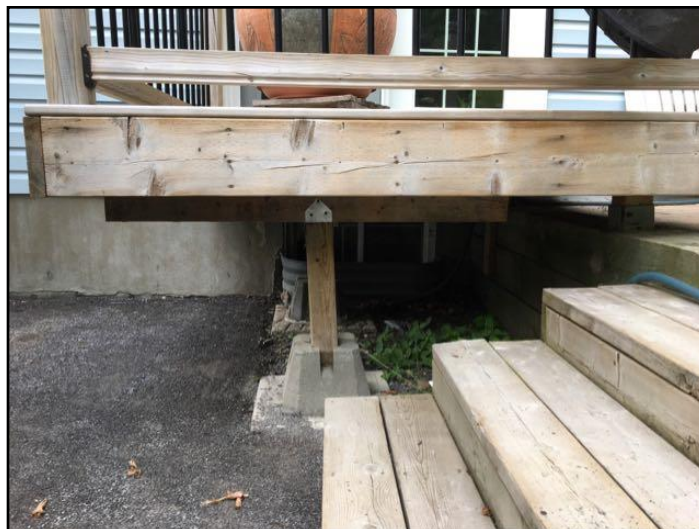
Condition: • [Leaning](#)

Implication(s): Weakened structure | Chance of movement

21. *Leaning*

Task: Repair

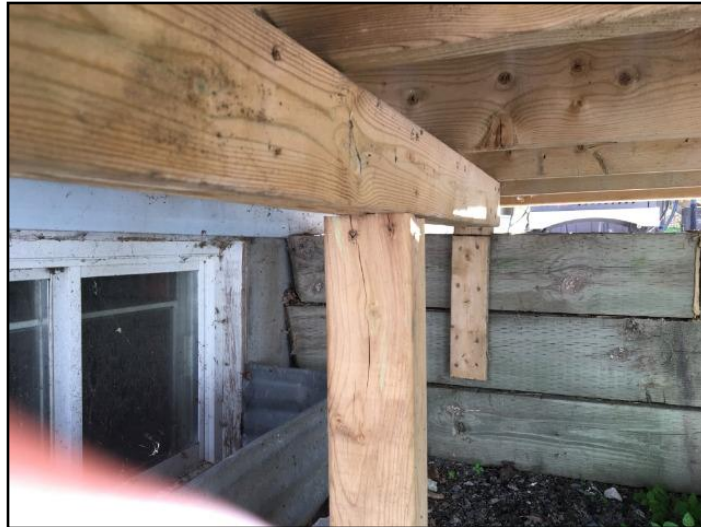
Condition: • [Connections weak](#)

Implication(s): Weakened structure | Chance of structural movement

22. Connections weak

Task: Repair

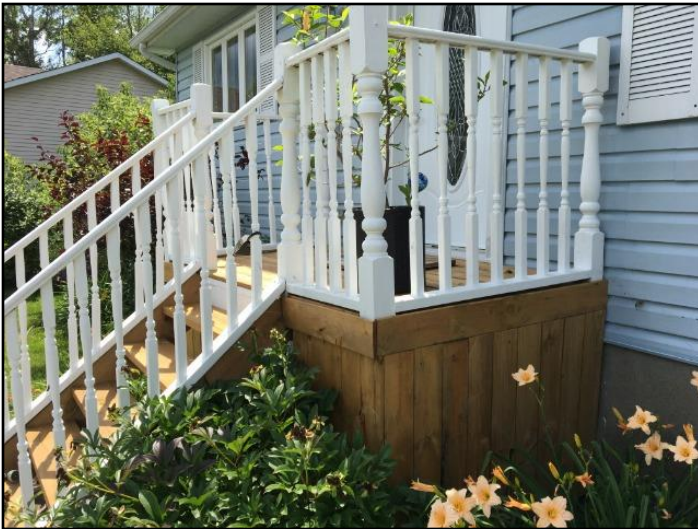
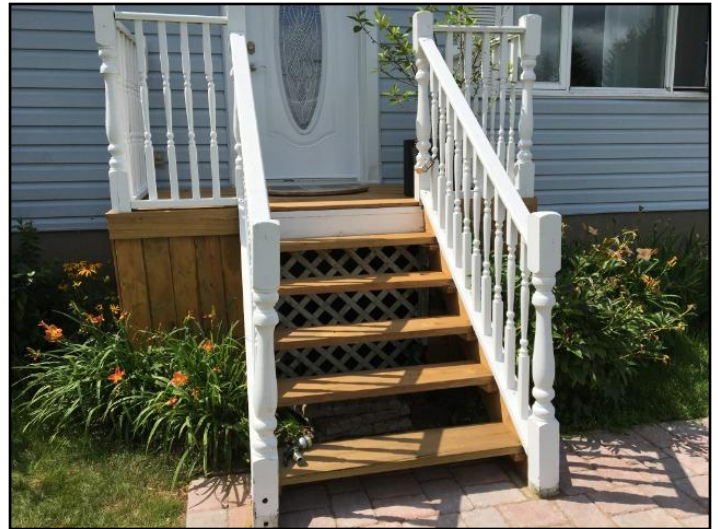
Condition: • [Loose](#)

Implication(s): Fall hazard

23. Loose

Task: Repair

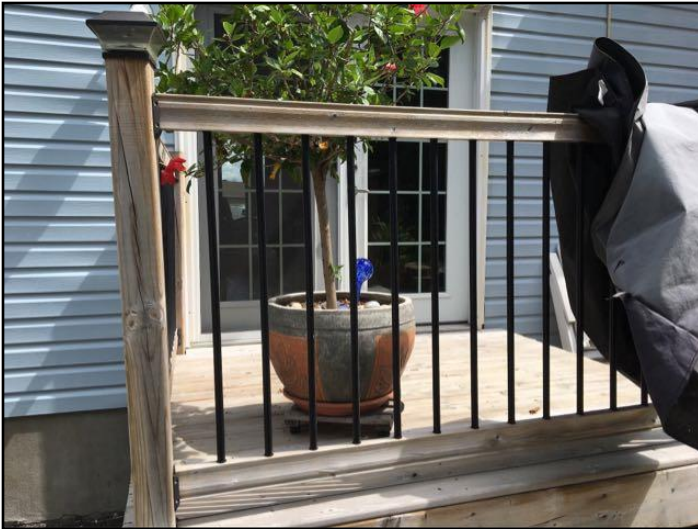
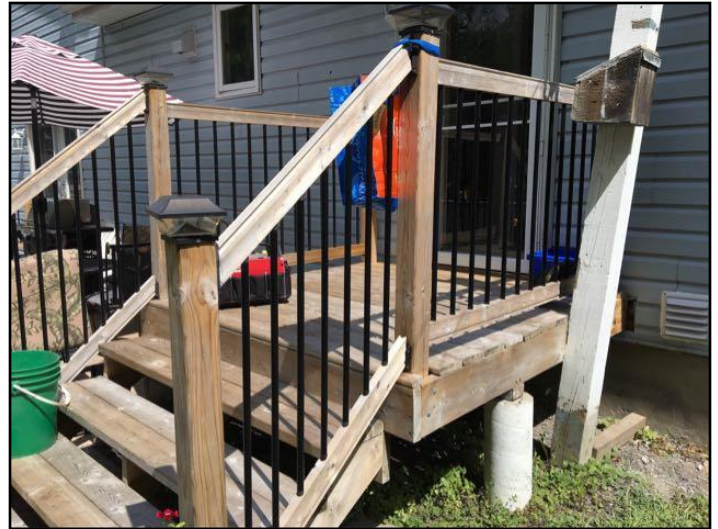
Condition: • [Loose](#)

Guardrails and handrails

Implication(s): Fall hazard

25. Loose

Task: Repair

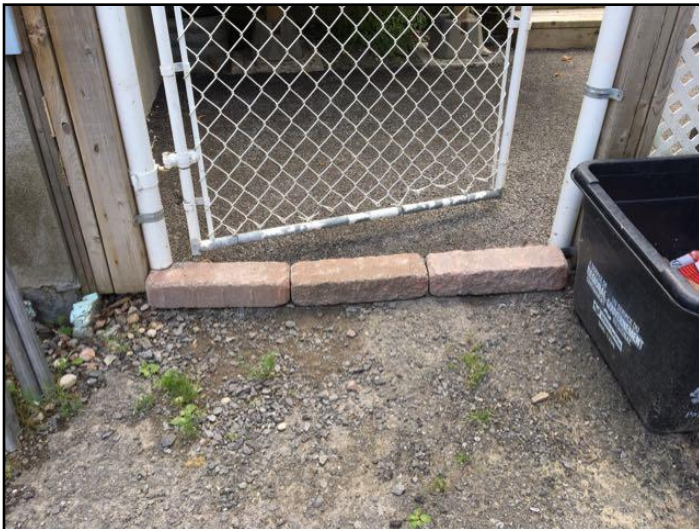
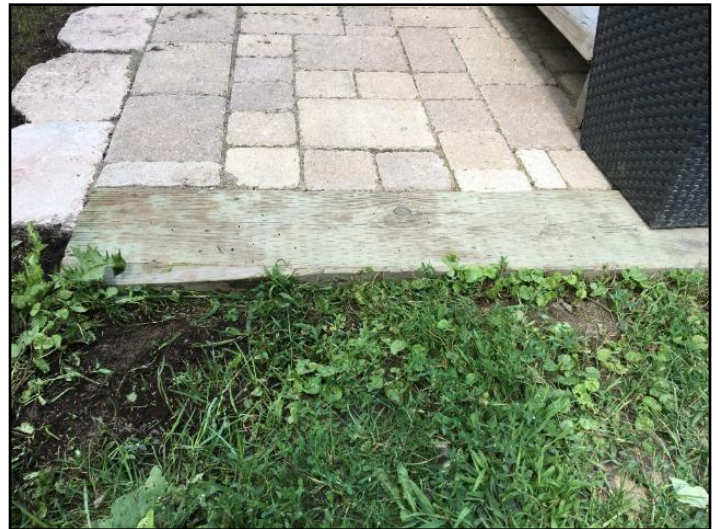
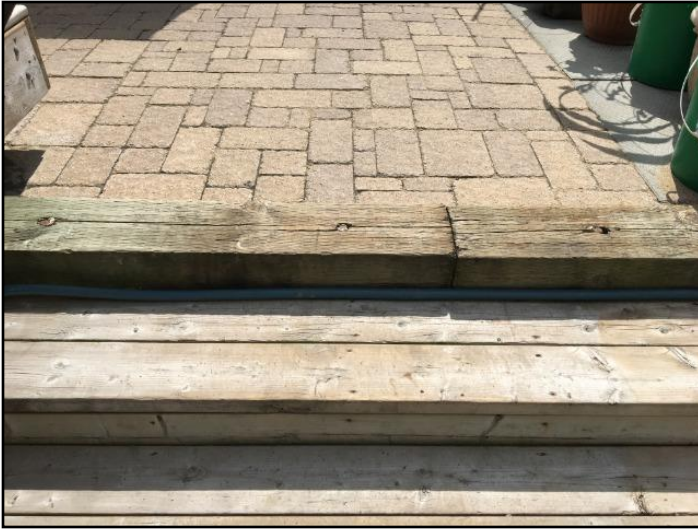
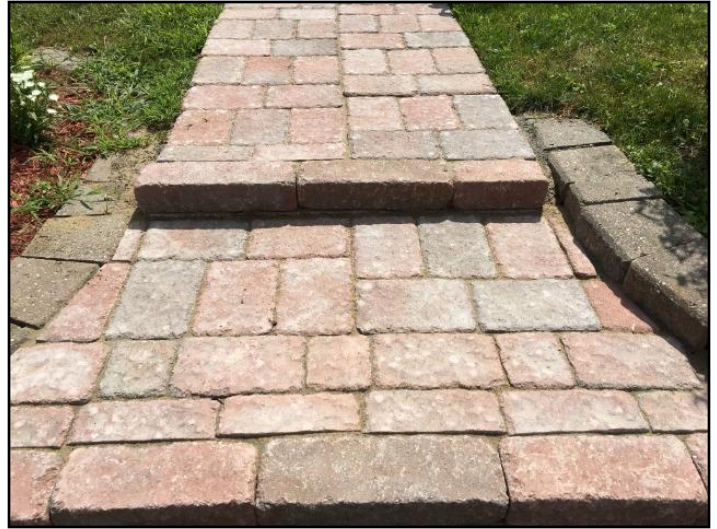
Condition: • [Uneven \(trip hazard\)](#)

Implication(s): Physical injury

27. Uneven (trip hazard)

Task: Improve

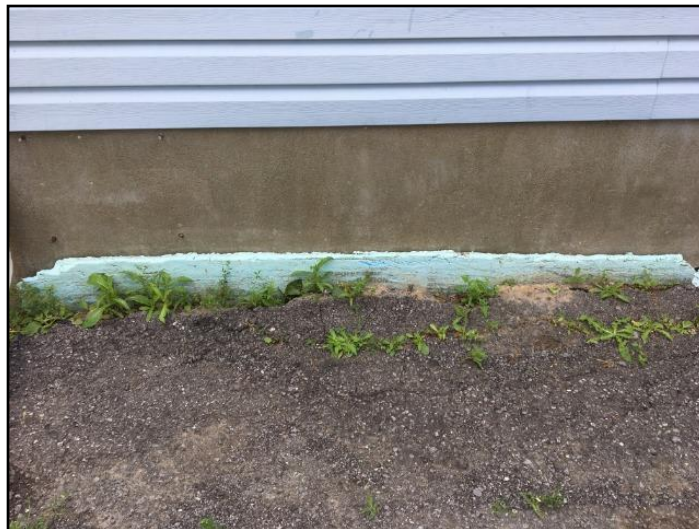
Condition: • [Cracked or damaged surfaces](#)

Implication(s): Trip or fall hazard

31. Cracked or damaged surfaces

Task: Improve

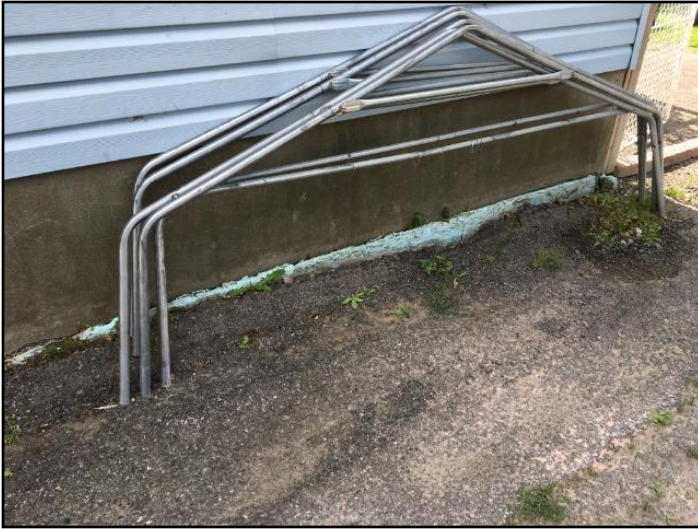
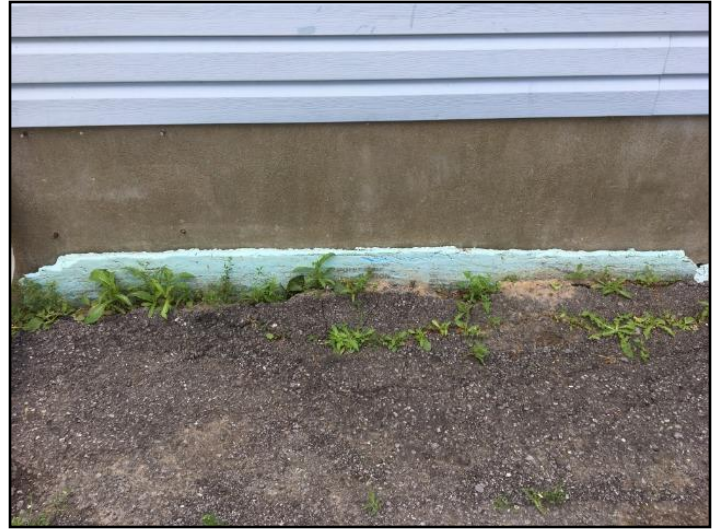
Condition: • [Unsealed gap at building](#)

Implication(s): Chance of water damage to contents, finishes and/or structure

32. Unsealed gap at building

Task: Repair

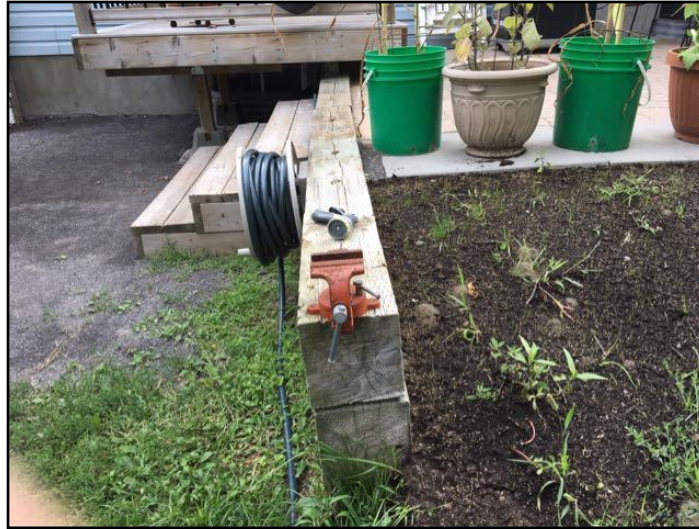
Condition: • [Leaning](#)

Implication(s): Weakened structure | Chance of movement

34. Leaning

Task: Repair

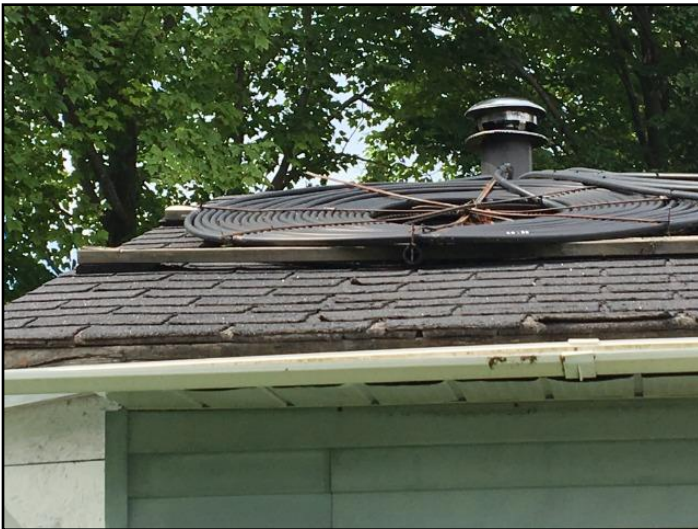
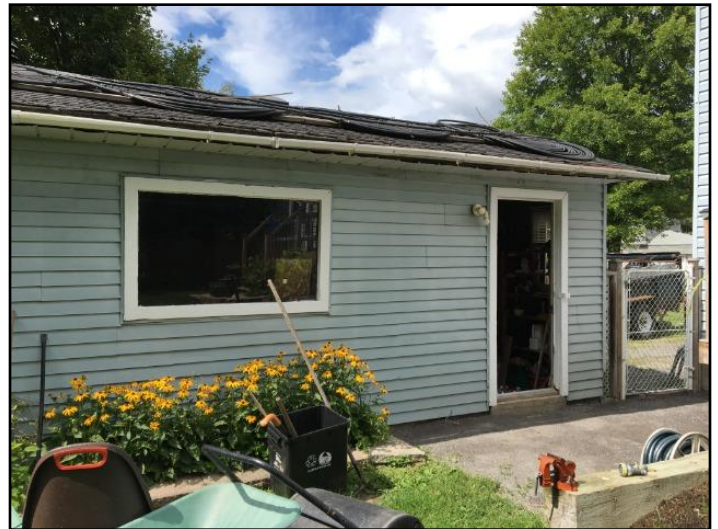
Condition: • Garage roof at end of life expectancy

Implication(s): Water leakage and damage to structure and contents

35. Disrepair

Task: Replace

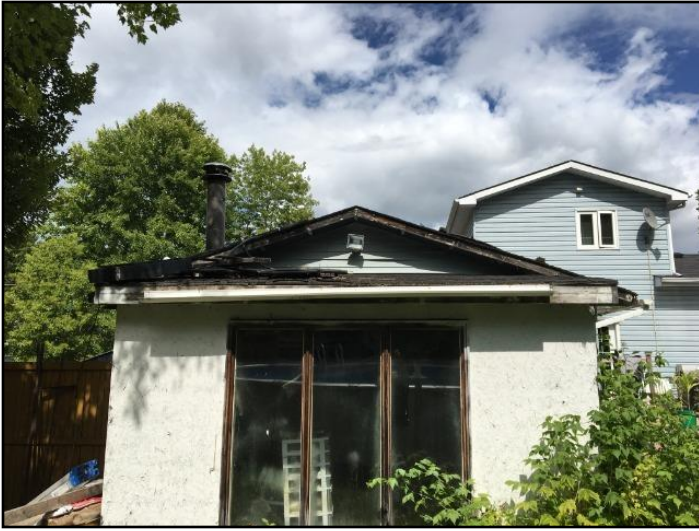
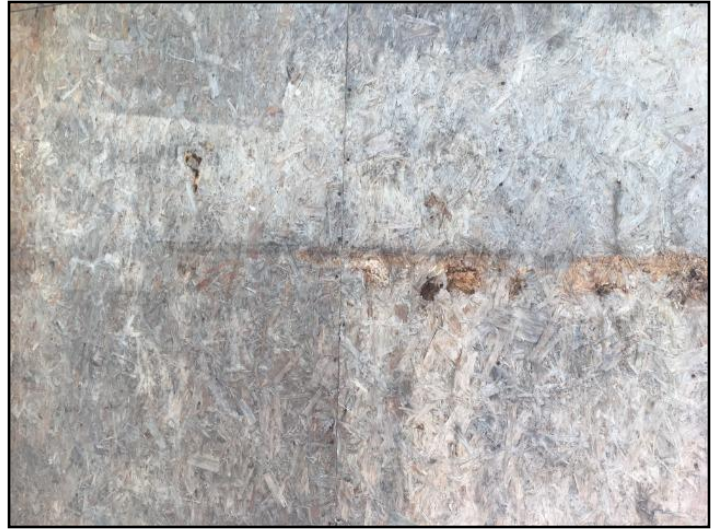
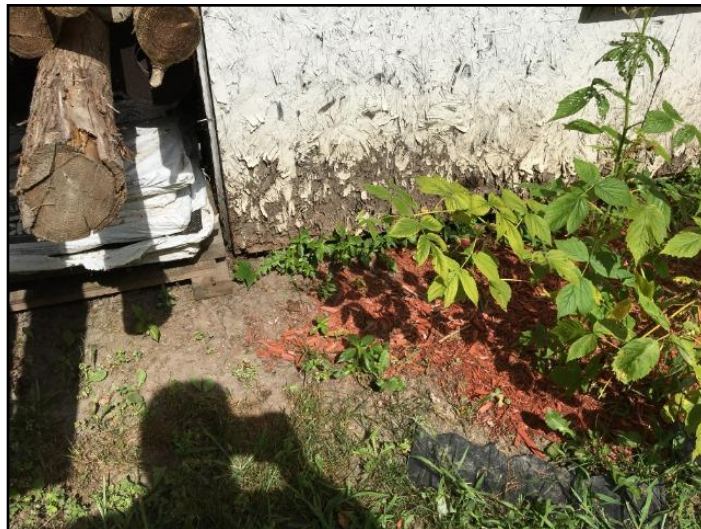
Condition: • Garage needs repairs throughout

Implication(s): Water leakage and damage to structure and contents

37. Disrepair

Task: Further evaluation

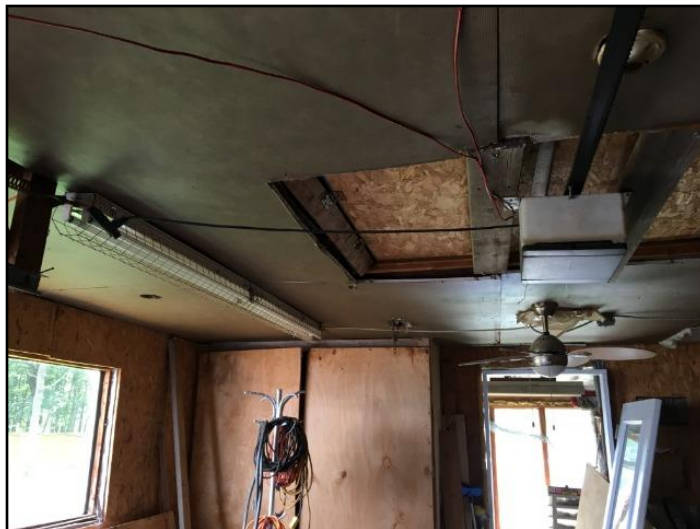
Condition: • [Extension cord for garage door opener](#)

Implication(s): Fire hazard

40. Extension cord for garage door opener

Task: Improve Correct

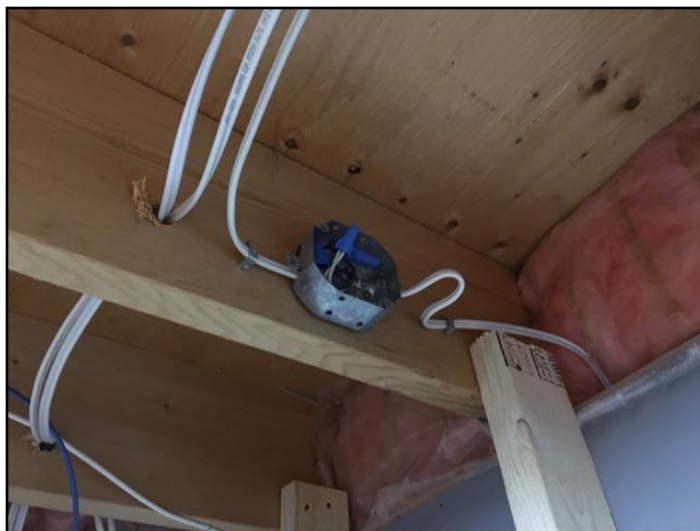
Condition: • [Cover loose or missing](#)

Implication(s): Electric shock | Fire hazard

41. Cover loose or missing

Task: Provide

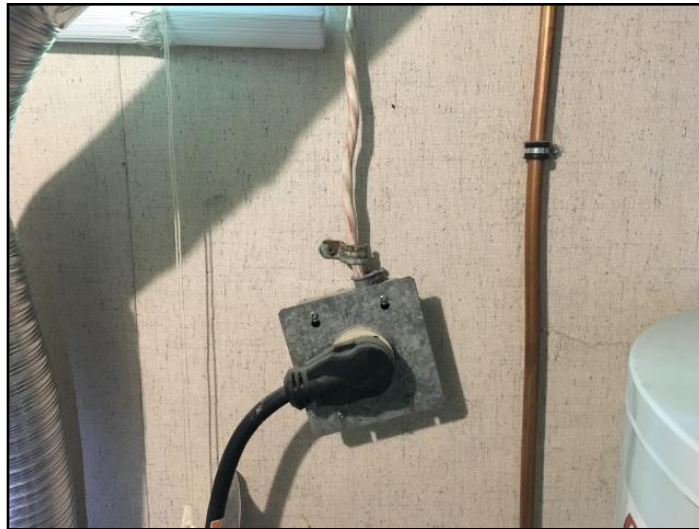
Condition: • [Loose](#)

Implication(s): Electric shock | Fire hazard

42. Loose

Task: Correct

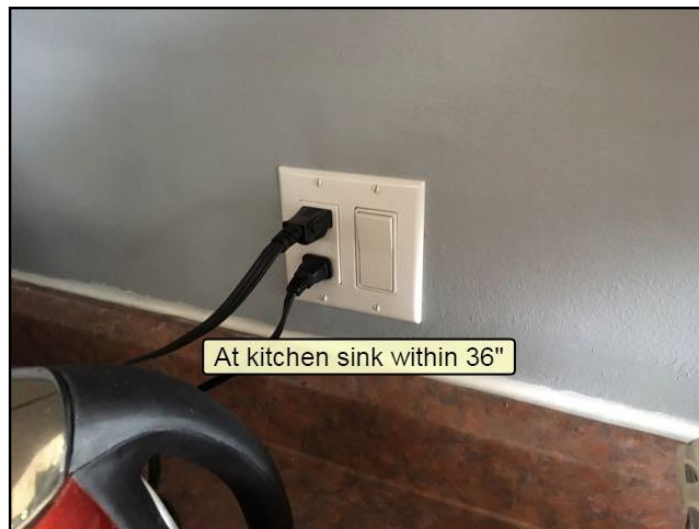
Condition: • [No GFCI/GFI \(Ground Fault Circuit Interrupter\)](#)

43. No GFCI/GFI (Ground Fault Circuit...

Task: Replace

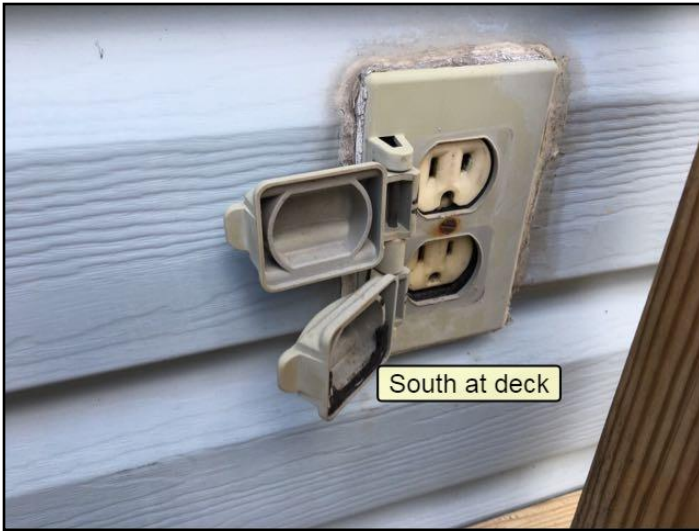
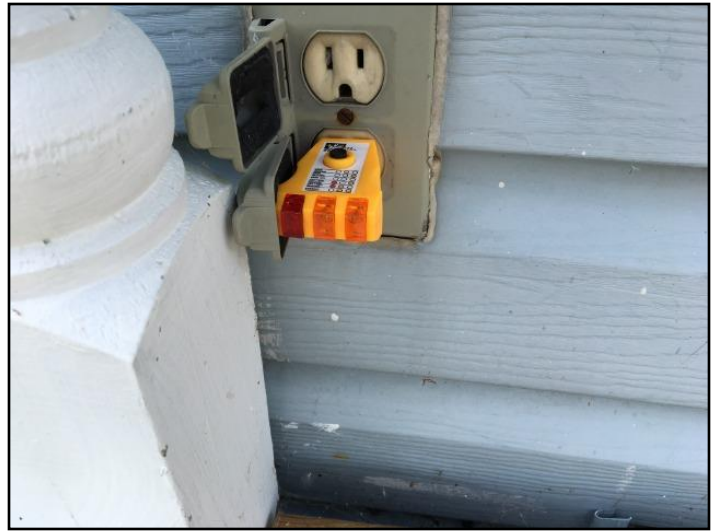
Condition: • [No GFCI/GFI \(Ground Fault Circuit Interrupter\)](#)

44. No GFCI/GFI (Ground Fault Circuitit...

Task: Replace

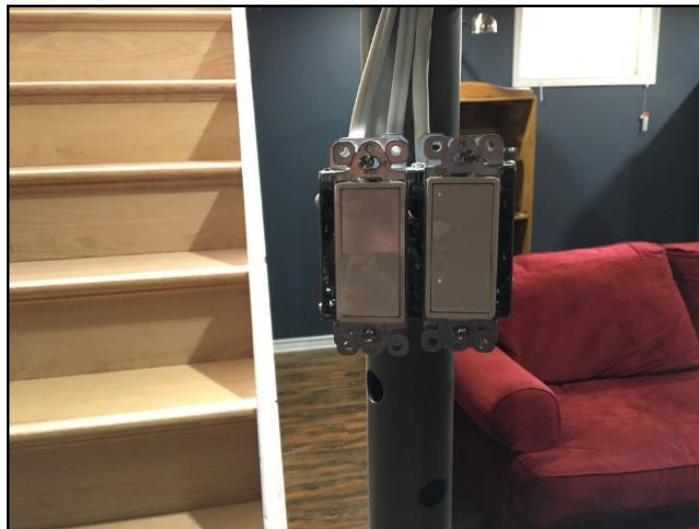
Condition: • Two lights switches are attached to metal support column. Noted that house is still under renovation and advised that this will be corrected.

Implication(s): Shock hazard

46. Poor location

Task: Improve Correct

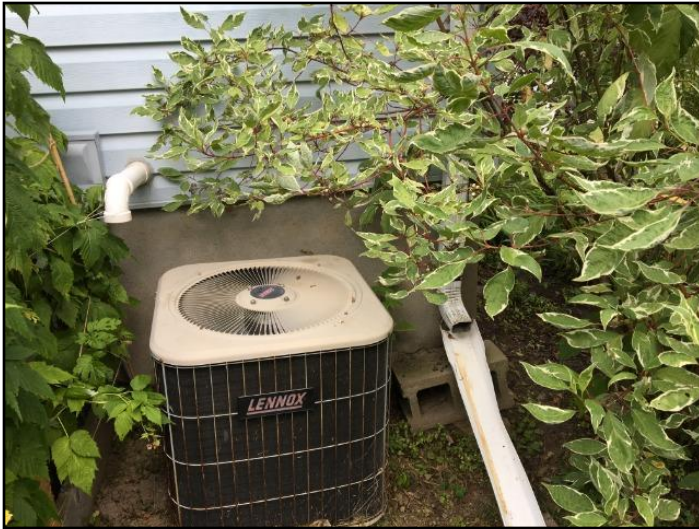
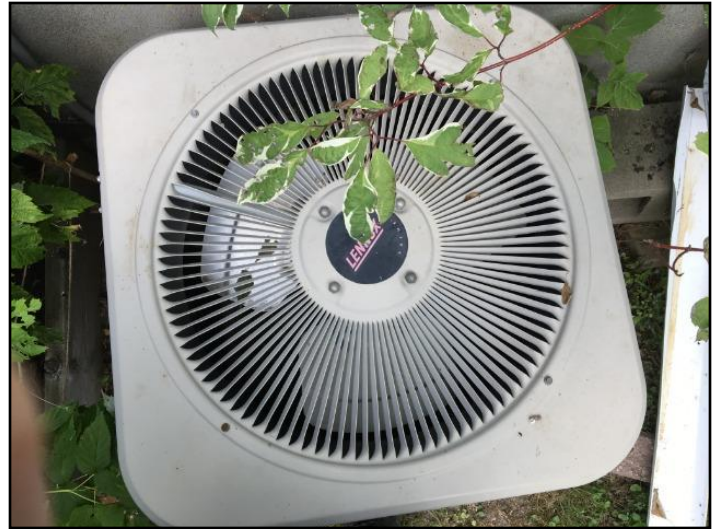
Condition: • Vegetation too close to AC unit.

Implication(s): Damage to AC unit/poor comfort

Task: Improve

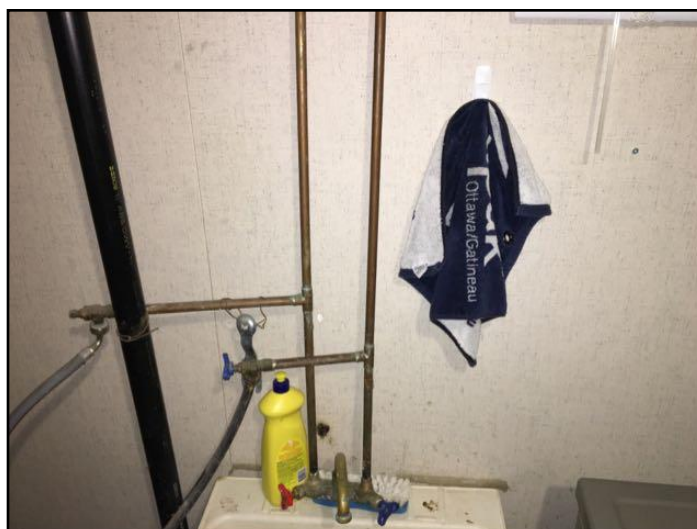
Condition: • [Loose](#)

Implication(s): Chance of water damage to contents, finishes and/or structure | Damage or physical injury due to falling materials | Sewage entering the building

50. Loose

Task: Repair

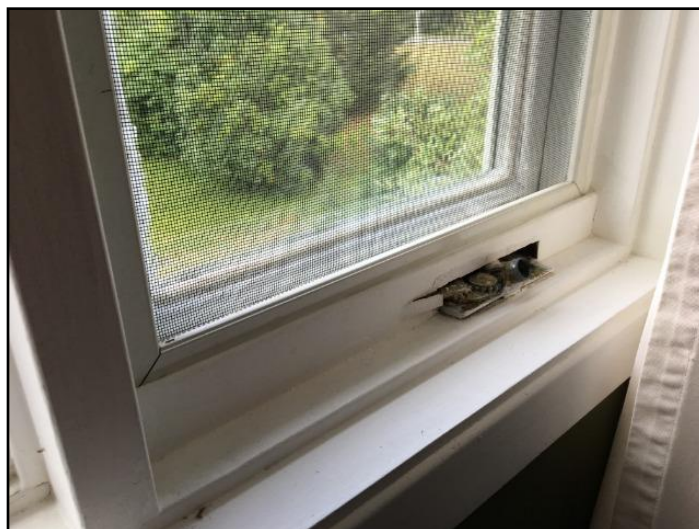
51.

Condition: • Window crank handle missing

Task: Provide

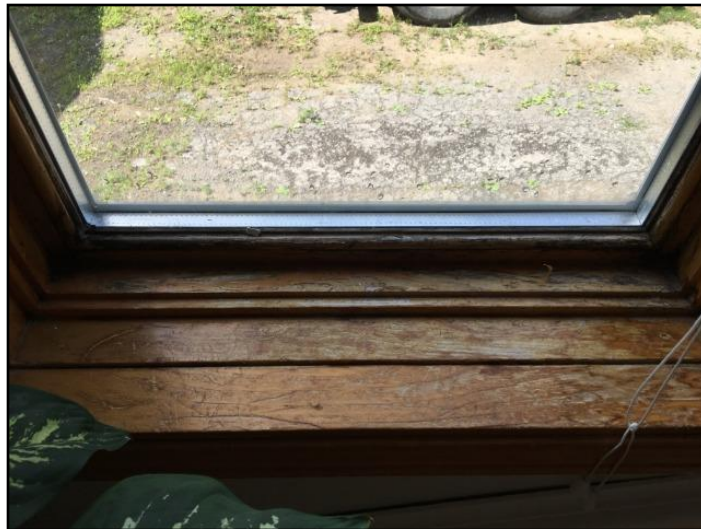
Condition: • [Rot](#)

Implication(s): Chance of damage to structure | Material deterioration

52. Rot

Task: Repair Monitor

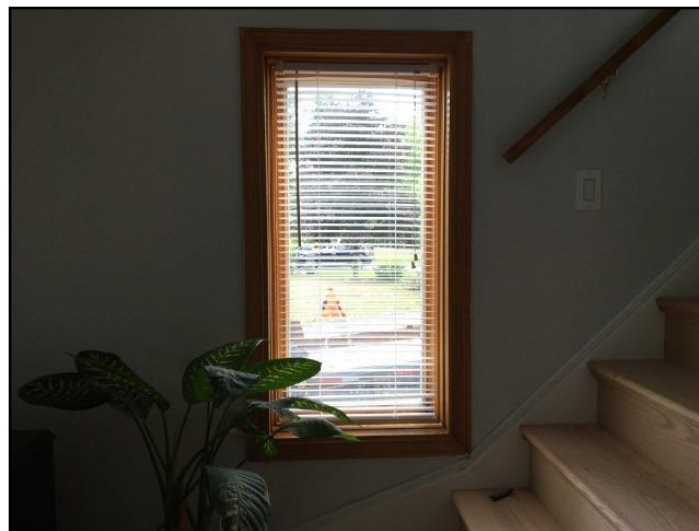
Condition: • [Sills too low on stairs](#)

Window on main floor staircase could be a fall hazard. Someone tripping on the stairs could fall through glass window.

Implication(s): Fall hazard

53. Sills too low on stairs

Task: Improve

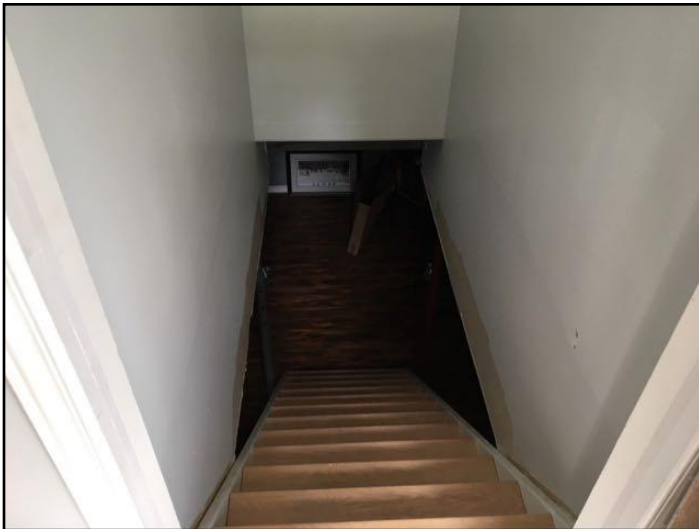
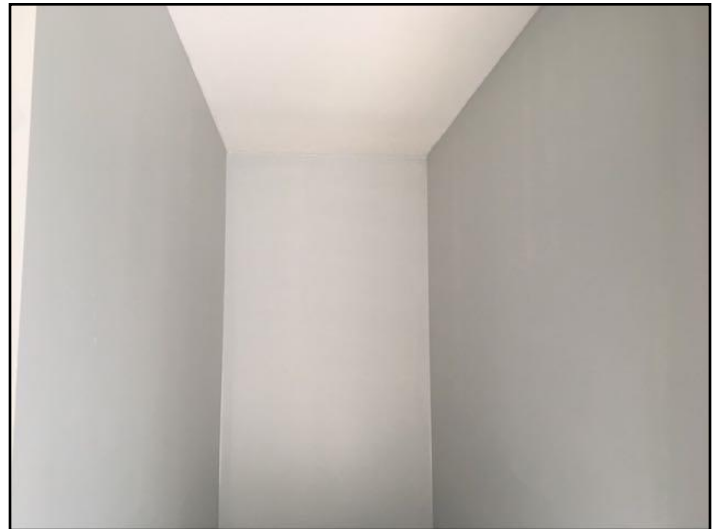
Condition: • [Missing](#)

Implication(s): Trip or fall hazard | Inadequate lighting

54. Missing

55. Poor lighting

stairway lighting requires switches at both the top and bottom of the stairs when the stairs have 4 or more risers (CAN) or 6 or more risers (USA)

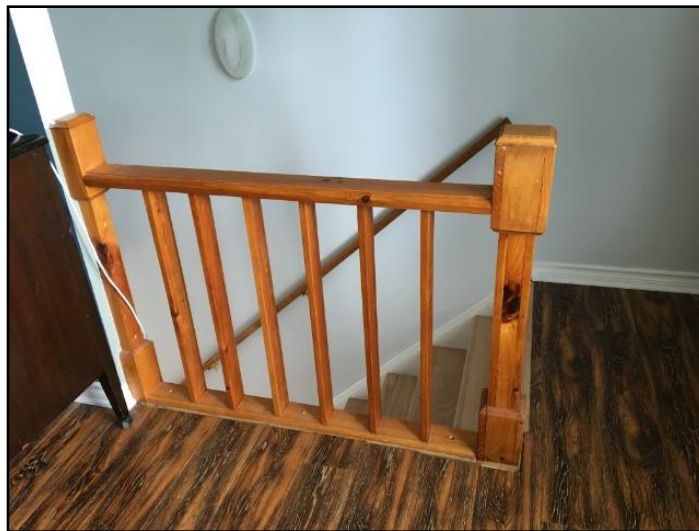
Condition: • [Loose](#)

Implication(s): Fall hazard

56. Loose

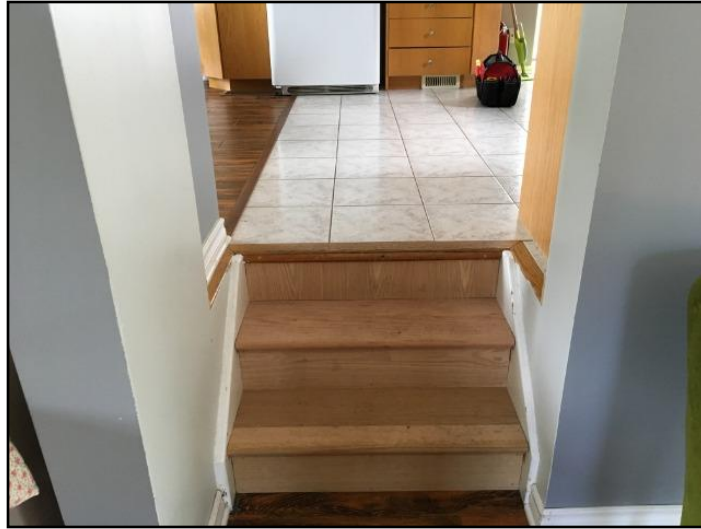
Condition: • [Missing](#)

Implication(s): Fall hazard

57. Missing

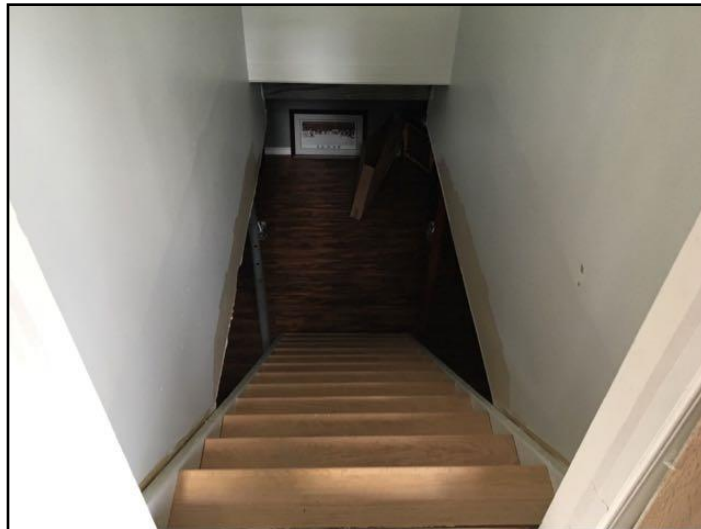
Condition: • [Missing](#)

Implication(s): Fall hazard

58. Missing

Task: Provide
