INSPECTION REPORT

For the Property at:
321 HIGH RD.
HAMMOND., ON K0A 2A0

Prepared for: JOHN DOE
Inspection Date: Saturday, August 10, 2019
Prepared by: Daniel Ducheneaux

RE: Report No. 1005, v.5
321 High Rd.
Hammond., ON
K0A 2A0

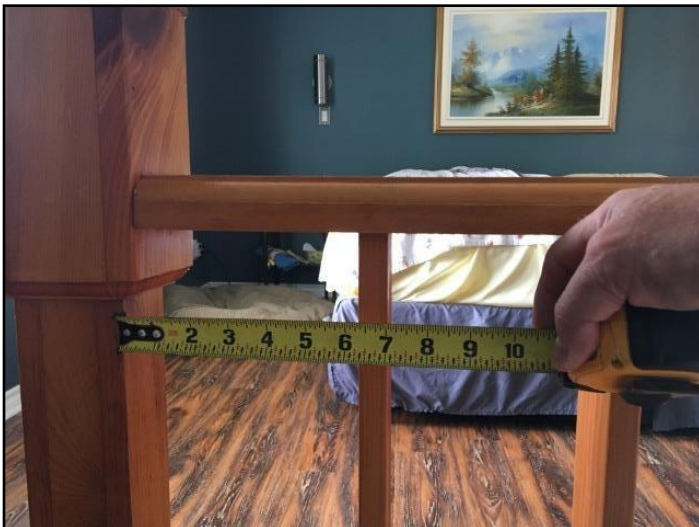
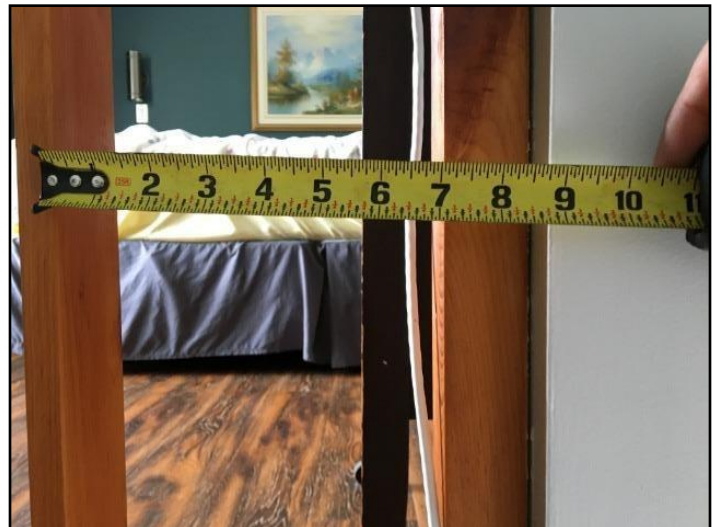
Condition: • [Too far apart](#)

Implication(s): Fall hazard

59. Too far apart

60. Too far apart

Task: Improve
